# APPLICATIONS BULLETIN

## Special Issue: Biomedical Applications

### Micro-mechanical properties of calcium phosphate coatings for titanium prostheses

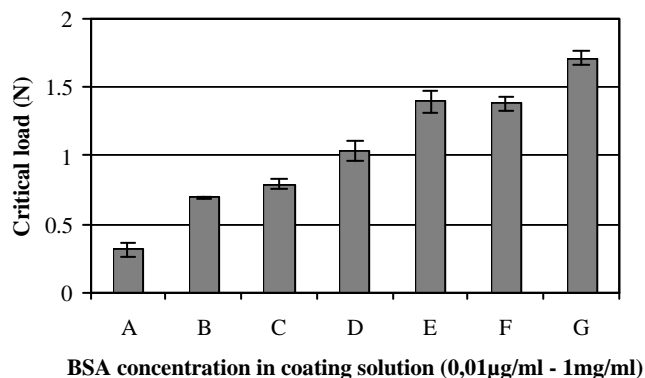
**Figure 1** : Micro-scratch test critical loads as a function of different BSA concentrations in the calcium phosphate coating. The general trend shows increased scratch resistance with BSA content.

Although calcium phosphate coatings can easily be characterised by conventional means (FTIR spectroscopy, X-ray diffraction, immunohistochemical evaluation, etc.), the mechanical properties are not so easy to obtain. The objective of this study was to investigate the correlation between BSA content and mechanical strength in a standard calcium phosphate coating. The dual-purpose Micro Combi Tester was used to evaluate the scratch resistance and microhardness of seven different coatings having BSA concentrations over the range 0.01  $\mu\text{g/ml}$  to 1  $\text{mg/ml}$ . Fig. 1 shows the almost linear correlation between BSA content and the critical load at which interfacial delamination occurred.

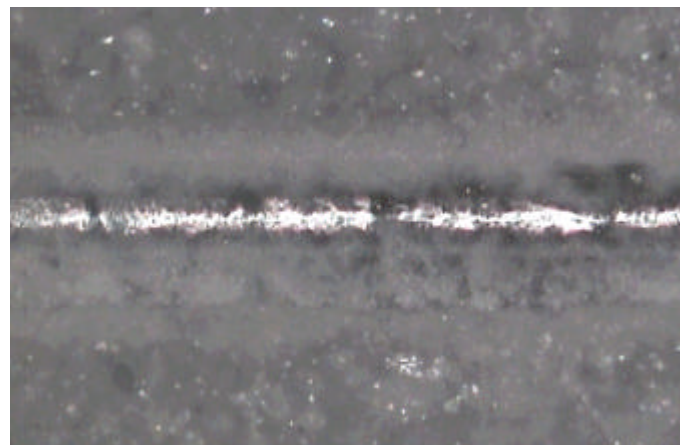
**Figure 2** : Typical scratch track on a BSA-containing calcium phosphate coating after a progressive load scratch up to 5 N with a 200  $\mu\text{m}$  diamond indenter.

Some deviation between successive scratches was observed due to the high porosity and surface roughness of the coatings and because of the mismatch between the very soft coating and the much harder Ti substrate. An example of a typical scratch is shown in Fig. 2 where the substrate has been reached. Microhardness results (Fig. 3), however, showed increased hardness up to a BSA concentration of 0.1  $\mu\text{g/ml}$  followed by a sharp decrease at 1  $\mu\text{g/ml}$ .

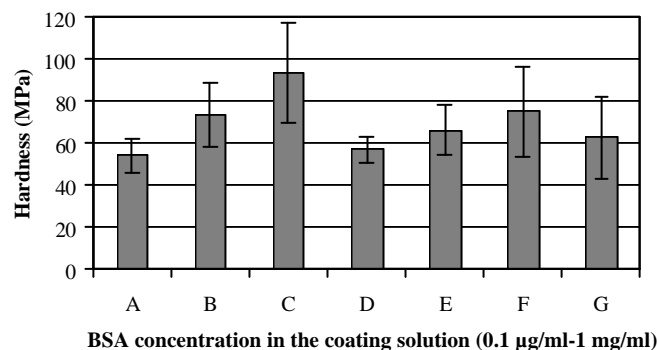
**Figure 3** : Microhardness results as a function of different BSA concentrations in the calcium phosphate coating. Measurements were made with a Vickers indenter and a maximum applied load of 1 N.

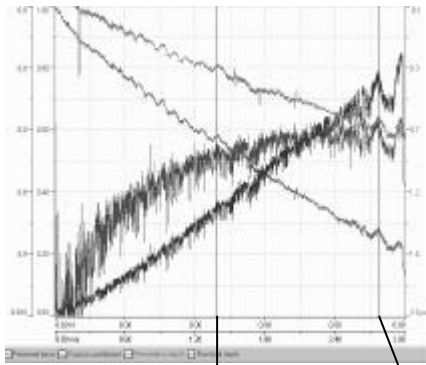
Contact lens technology has seen many advances in recent years. One of these is intra-ocular implantation of the lens between the cornea and the iris. The soft lens is injected into a small incision and then spread out under the iris. Coatings are used to ensure sufficient biocompatibility with the contacting tissues and can be easily characterised with the Nano Scratch Tester using very low loads ( $< 50$  mN). The soft lens is flattened on a plate with a drop of water which keeps it flat during the test (by capillary forces) and ensures that it remains sufficiently humidified. The force feedback of the instrument follows any curvature of the surface.

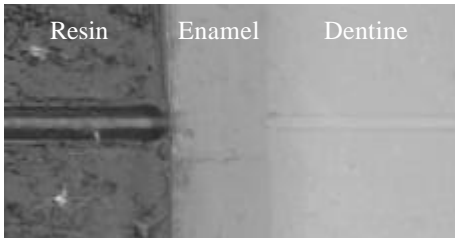
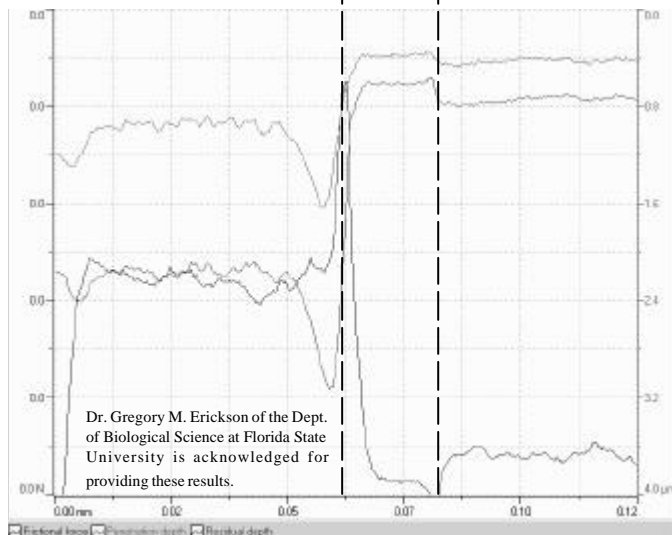
The tooth is a craniofacial structure that is the focus of intensive tissue engineering studies. The outer enamel layer is almost 95% mineral, the hardest structure in the human body. During formation, enamel consists of a protein matrix that forms the framework for mineral deposition. If the matrix proteins can be identified and cloned then such knowledge can be used to replicate the natural enamel-forming process. The nano scratch test has been used to determine mechanical properties of polished tooth sections as shown below. A constant load scratch (5 mN) is shown across the interface between the dentine, enamel and mounting resin. The differences in hardness are evident from the depth plots and it is interesting to note that variations in friction coefficient between the enamel and dentine are also well characterised.

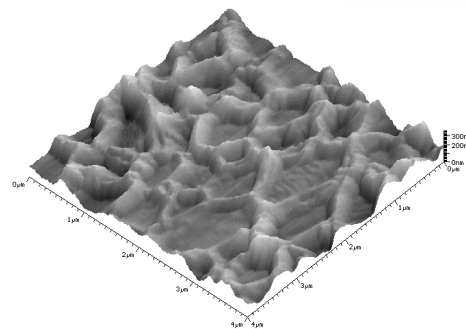
Scanning Force Microscopy (SFM) is used to characterise the surface roughness (3D image shown above) of the coating and the Linear Tribometer can be made to simulate opening and closing of the valve. Coating failure can be detected by plotting frictional variations as shown in the example below.

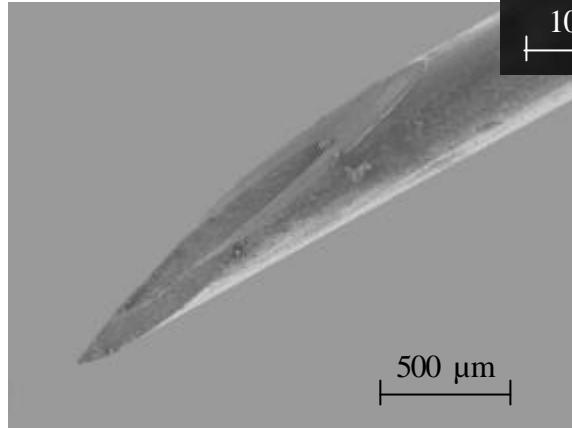
The hardness distribution from the outer edge to the centre will vary depending upon the heat treatment used during fabrication of the stainless steel needle. The above micrograph shows a series of nanoindentations made with maximum load 5 mN through a sectioned and polished needle tip. This allows the hardness to be profiled in predefined steps. The Scanning Electron Microscope (SEM) image on the left shows a typical syringe needle tip.

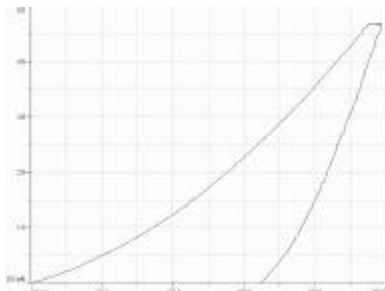
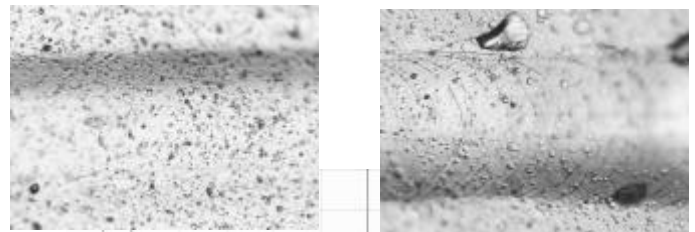
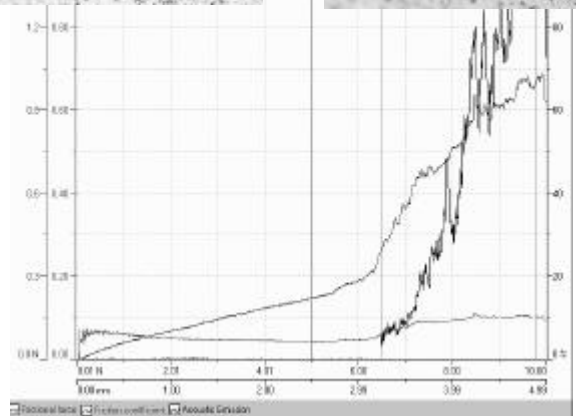
The inorganic component of bone makes the tissue hard and rigid whereas the organic component gives bone its flexibility and resilience. The strength of a bone is directly related to the distribution of mineral within it and can be measured with the Micro Hardness Tester. The resulting hardness values at different points across a polished bone section give a measure of Bone Mineral Density (BMD) which is an accurate indicator of fracture risk.

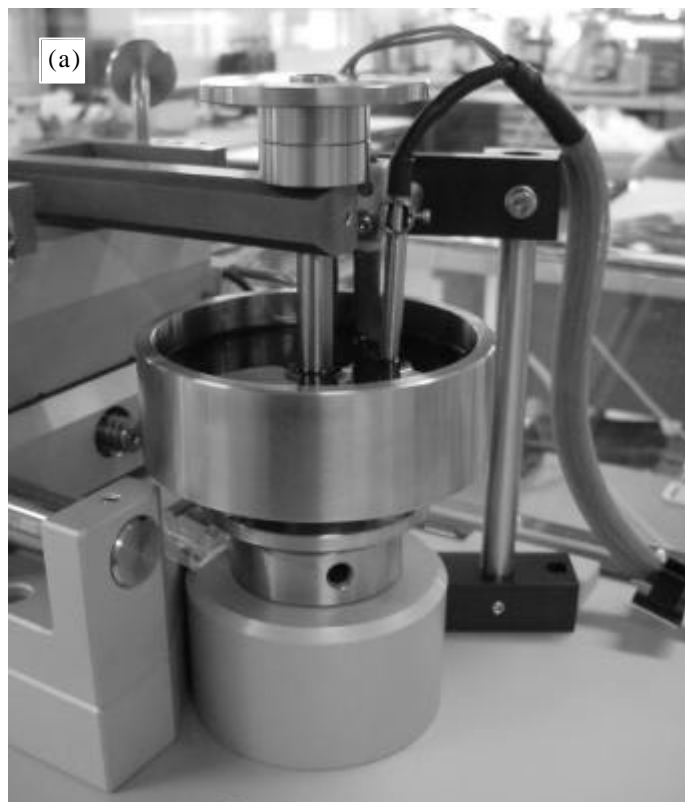
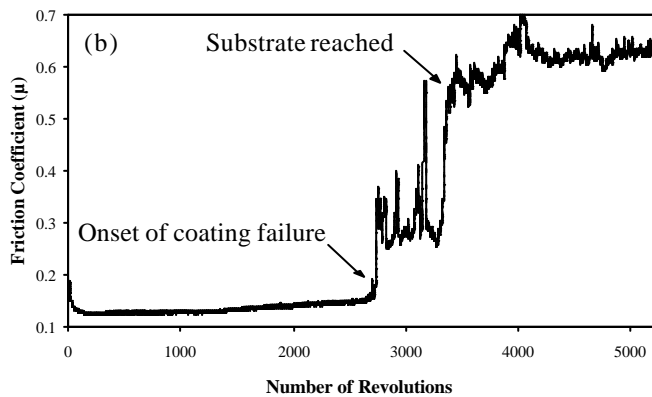
A typical result is shown in Fig. 1 (b) for a tin oxide coating in contact with a 100Cr6 ball. The applied load was 2 N, linear speed 10 cm/sec. and wear radius 3 mm.

**Figure 1 :** Liquid heating option mounted on the standard Tribometer (a) and typical result (b) of friction coefficient plotted as a function of number of revolutions for a tin oxide coating spin-coated onto a stainless steel substrate.

This result shows the initial running-in period, after which the friction coefficient stabilises at a value of approximately 0.13 before increasing gradually until first failure of the coating occurs. The coating then breaks down and when the substrate is reached, the friction coefficient stabilises at a value of about 0.64. The test was paused at significant points to allow SEM imaging of the wear track (see Fig. 2) which confirmed the state of failure of the coating

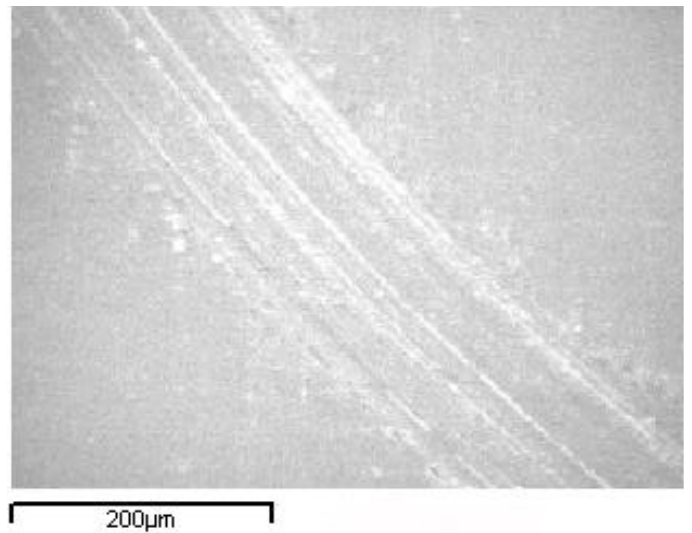
**Figure 2 :** Scanning Electron Micrograph of the residual wear track after the test described in Fig. 1 (b) showing delamination of the tin oxide coating from its stainless steel substrate.
